Manhole Inspection Summary

Manhole # S53E__014MH

Insp Date: **4/29/08 8:30 AM**

Location Address: **10 leverton ave**

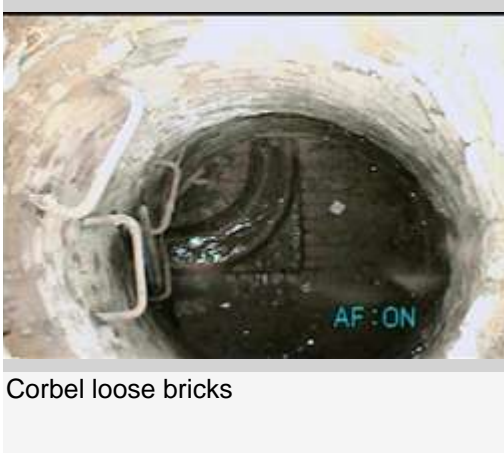
Defect 1

Corbel loose bricks

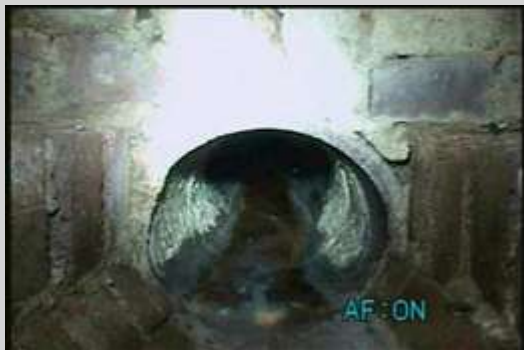
12 O'Clock Outflow

8 in. Circular Gravity Sewer
Pipe Out @ 12 O'Clock

Pipe Material: **Clay** ☐ Pipe Lined

Invert Depth: **8.50** (ft.) Flow Characteristics: **Fast**

Infiltration: **None** Pipe Seal Cond: **Unknown**

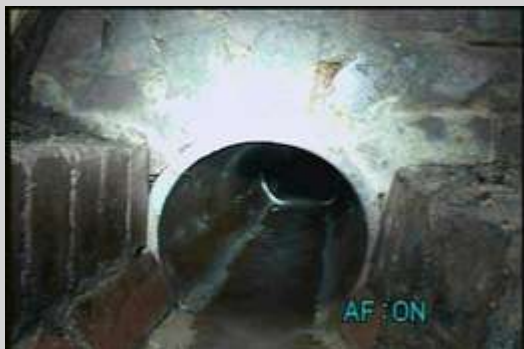
9 O'Clock Inflow

8 in. Circular Gravity Sewer
Pipe In @ 9 O'Clock

Pipe Material: **Clay** ☐ Pipe Lined

Invert Depth: **8.30** (ft.) Flow Characteristics: **Fast**

Infiltration: **None** Pipe Seal Cond: **Unknown**
